Orbital Debris Collection Experiment (ODC):

Progress Report

(Jan. - June, 1998)

SEE Experiments Workshop
Huntsville, AL.
June 23-25, 1998

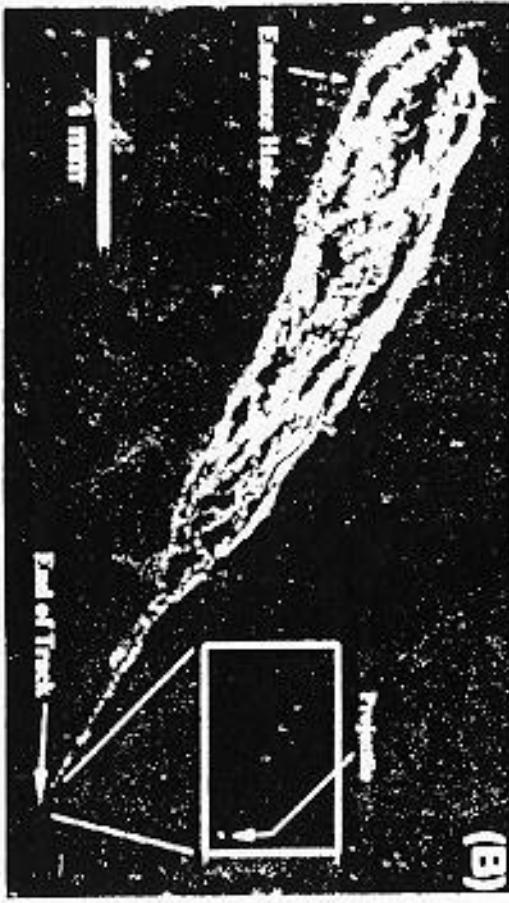
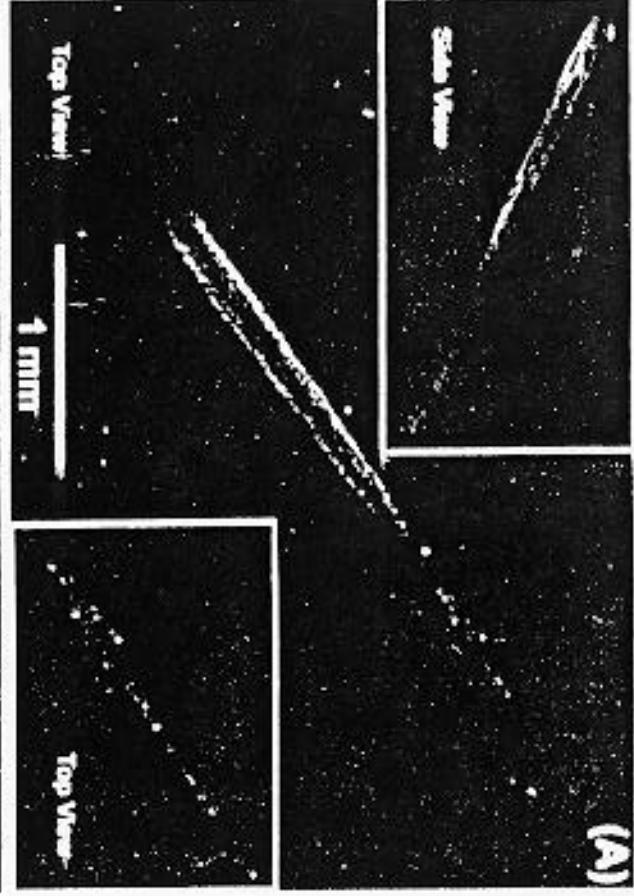
1A01-9
Transmitted Light

500 μm

Reflected

Transmitted

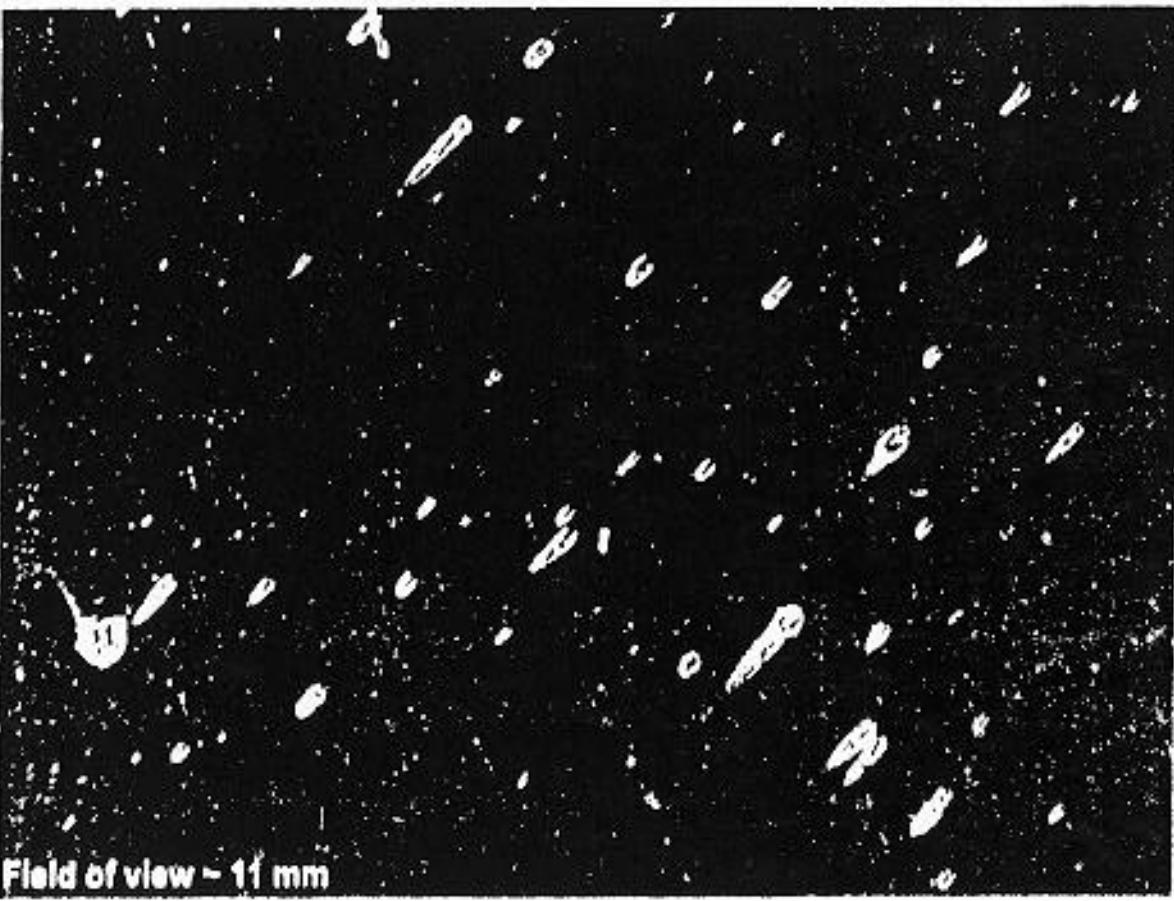
Field of view ~ 11 mm
